(51) International Patent Classification ⁶: H02K 15/00, 3/22, 3/50	A1	(11) International Publication Number: WO 98/21809 (43) International Publication Date: 22 May 1998 (22.05.98)

(54) Title: WATER-COOLED STATOR COIL END SEALING PROCESS

WATER-COOLED STATOR COIL END SEALING PROCESS**FIELD OF THE INVENTION**

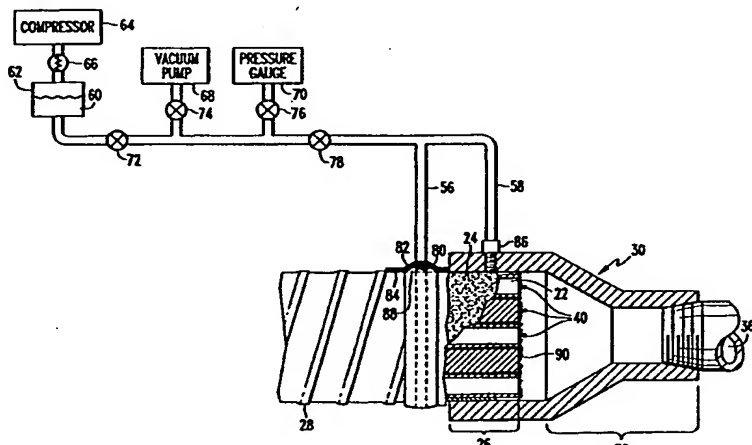
(57) Abstract <p>A process is disclosed for repairing leaks in turbine generators that have water-cooled stator coils with hollow conductor strands, wherein the lead ends of the conductor strands are joined to a header (30). First a vacuum enclosure is provided around a portion of one of the stator coils in proximity to the header. Then a vacuum is applied to the portion. Finally, a resin (24) is injected into voids (40) in the portion. In a second embodiment, the header first is cut into an outboard section, and into an inboard section that remains attached to the conductor strands. Then the exposed lead ends of the conductor strands and the attached inboard section are cleaned to remove oxidation. Next, a water-tight braze seal (90) is applied over the lead ends of the conductor strands. Then the stator coil and the inboard section are joined to a new outboard section and a vacuum is subsequently applied to the inboard section. The resin (24) is then injected into voids (40) in the inboard section.</p>

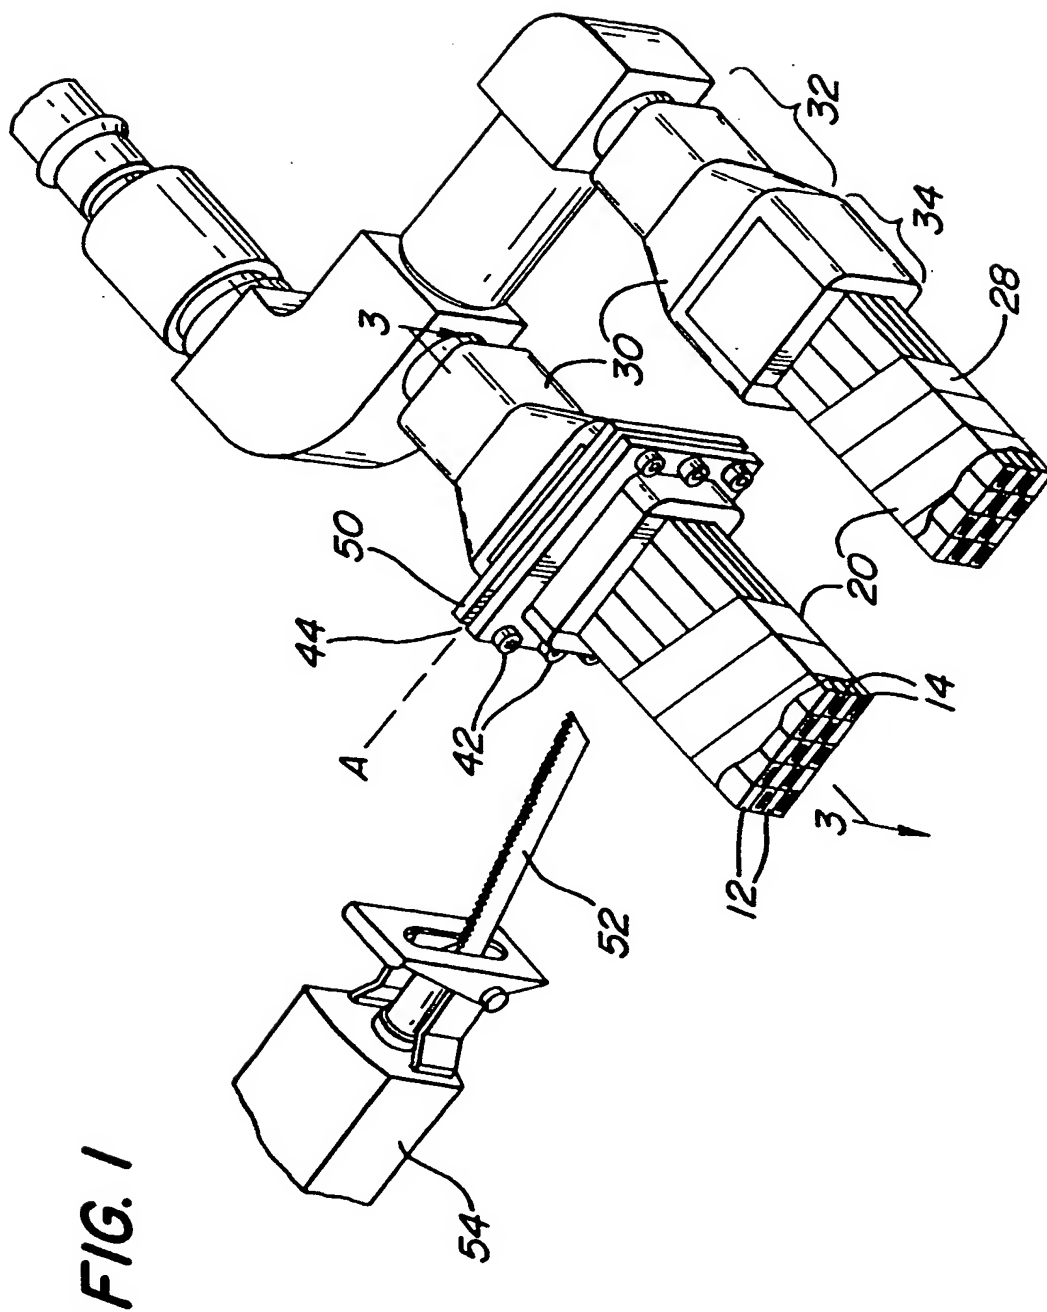
5 Figure 1 illustrates a water cooled header connected to stator coils;

Referring to the drawings wherein like numerals indicate like elements throughout, Figure 1 depicts the header and stator coil sub-assembly that may be susceptible to the water leakage problem discussed above. In this design, the hollow conductor strands 14 and solid conductor strands 12 are bundled together to form a stator coil 20. After the conductor strands are bundled together and bent to the desired form, an epoxy resin binds the conductor strands 12, 14. The entire stator coil 20 assembly is then wrapped with a groundwall insulation 28. At the lead end 26 (as shown in Figure 3) of the stator coil 20, where the stator coil 20 joins the header 30, the conductor strands 12, 14 are exposed to facilitate the connection. Thus, the conductor strands 12, 14 are not epoxied or wrapped with the groundwall insulation 28 at that point. This lead end 26 of stator coil 20 is extended into the header 30 to interface stator coil 20 to header 30, completing the electrical/hydraulic circuit.

35 As illustrated in Figure 1, during a repair process in accordance with one embodiment of the invention, the header 30 and stator 20 interface is placed in an

alignment fixture 50, which is mounted directly to the header 30. This alignment fixture 50 has two halves that are bolted together with bolts 42 leaving alignment guide slot 44 for the saw blade 52 to travel through the header 30. Initially, several of the bolts are removed. As the saw moves through the alignment guide slot 44 and cuts through the header 30, the removed bolts are replaced and other bolts are removed. Thus, the alignment fixture 50 ensures that the cut is square while the saw 54 cuts through the header. After the sectioning is completed, the non-brazed leading portion 22 of the stator coil 20 is exposed. The voids 40 between the conductor strands are then accessed through the opening provided by the outboard portion 34 of sectioned header 30. The result of sectioning the header 30 and the accompanying accessibility to the non-brazed leading portion 22 of the stator coil 20 is illustrated in Figure 2.

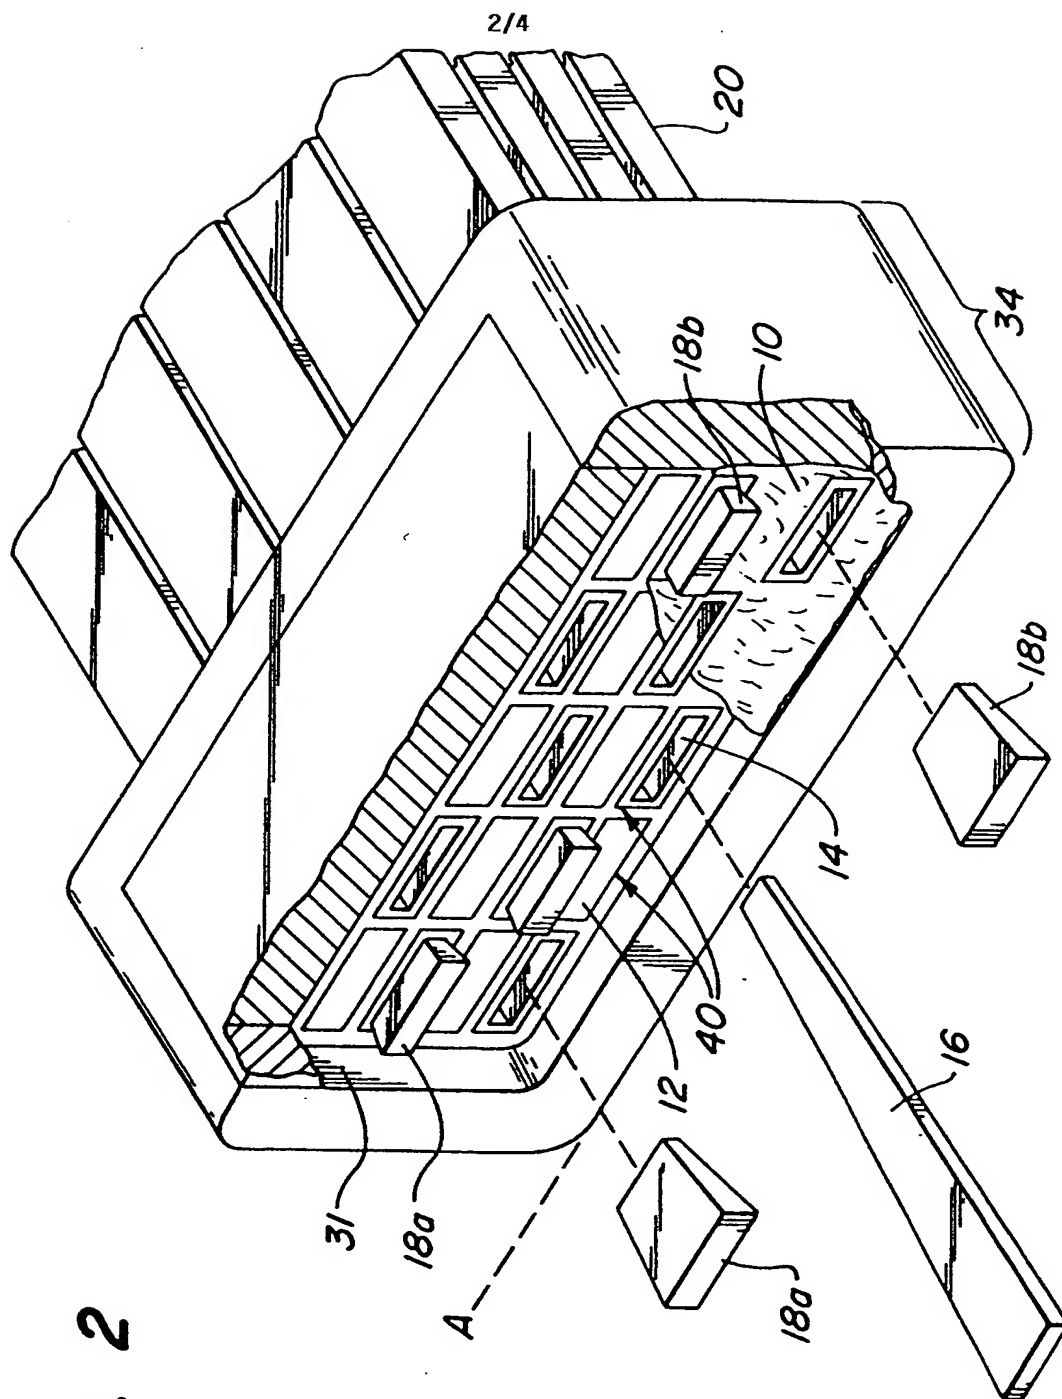
FIG. 2

Figure 2 illustrates a view of the stator coil and a section of the header remaining attached thereto;

appreciated from the cross-sectional view provided in Figure 2. As shown, columns and rows of the voids 40 exist between the conductor strands 12, 14 of the stator coil 20. These voids 40 must be sealed to prevent the development of leak-causing acid.

strands are again plugged before applying the braze seal
10. The polyurethane plugs 18a, used during the cleaning
process, are not suitable for this purpose because of the
high temperatures experienced during the brazing. Instead,
5 a similarly shaped and sized plug 18b is formed of a high
temperature ceramic material, which is inserted in place of
the polyurethane plugs. Moreover, to prevent heat damage
to the insulation in the stator coil 20, chill blocks are
attached to the stator coil 20 to keep the temperature of
10 the stator coil 20 in an acceptable range during the
brazing process. Finally, a new header is joined to the
sealed stator coil 20 and the header section that remains
attached thereto.

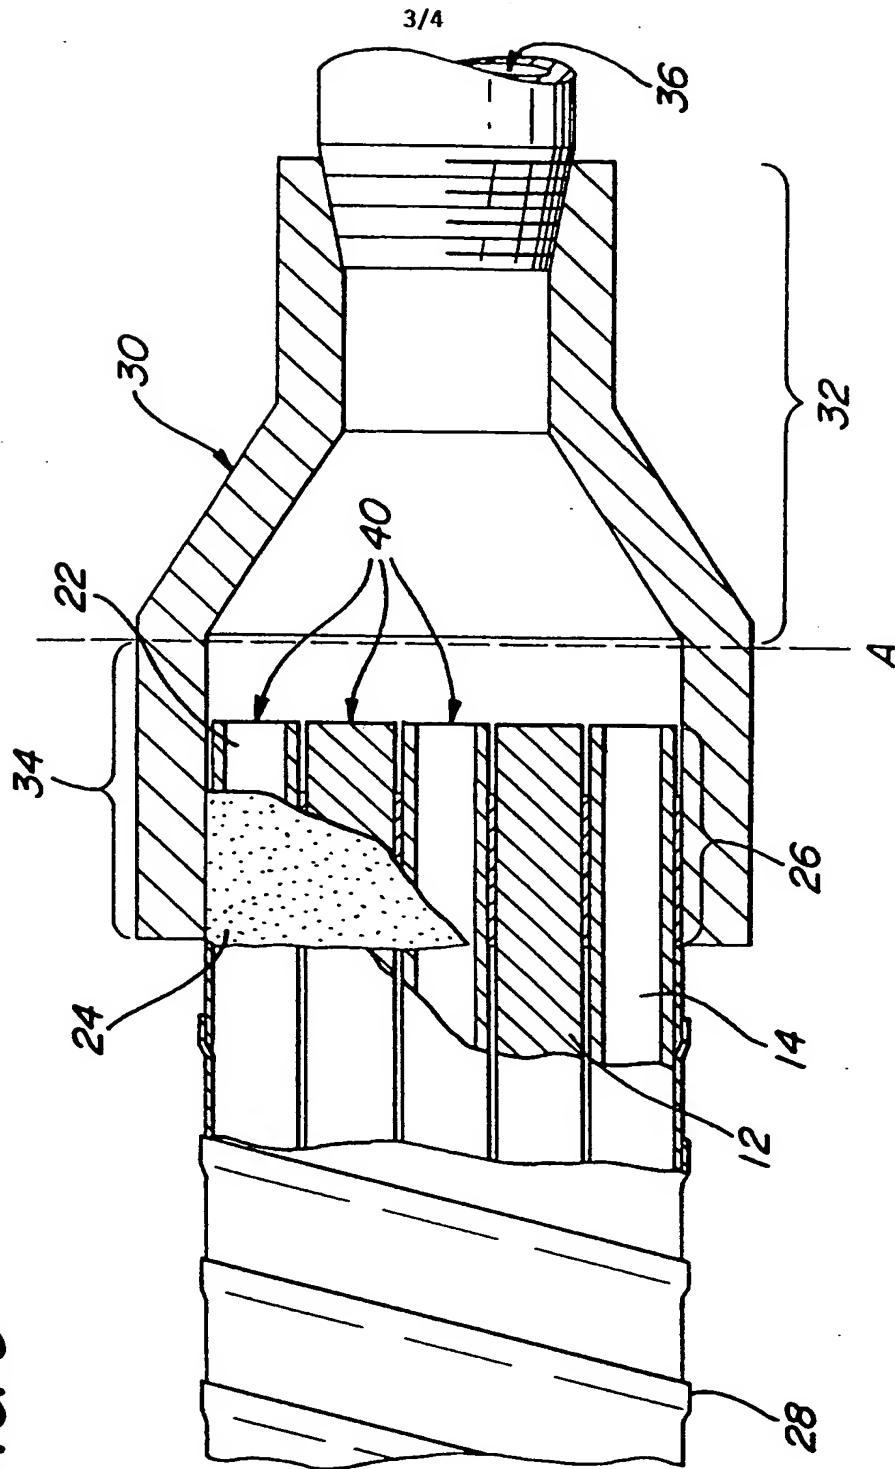
FIG. 3

10 Figure 3 illustrates a side view of the stator coil lead ends inserted into the header; and

Figure 3 shows a cross section of the stator coil 20 and header 30 interface taken along the line 3-3 in Figure 1. In a typical configuration, the stator coils 20 are inserted into the openings in the header 30 at the inboard side 34 of the header 30. Water flows through opening 36 to cool the stator coils 20 during operation of the turbine generator (not shown). As illustrated, only the trailing portion 24 of the lead end 26 is brazed to header 30. The leading portion 22 is not brazed to the header 30, leaving column and row voids 40 between the conductor strands 12, 14. Additionally, a void 40 exists between the walls of the header and along the non-brazed leading portion 22 of the stator coil 20. Problematically, coolant water tends to permeate back through voids 40 and mix with the flux used in the original brazing process. This water and flux mixture forms an acid which eats through the braze and continues back into the stator coil 20 and the groundwall insulation 28. If left uncorrected, this leakage could cause a failure in the generator.

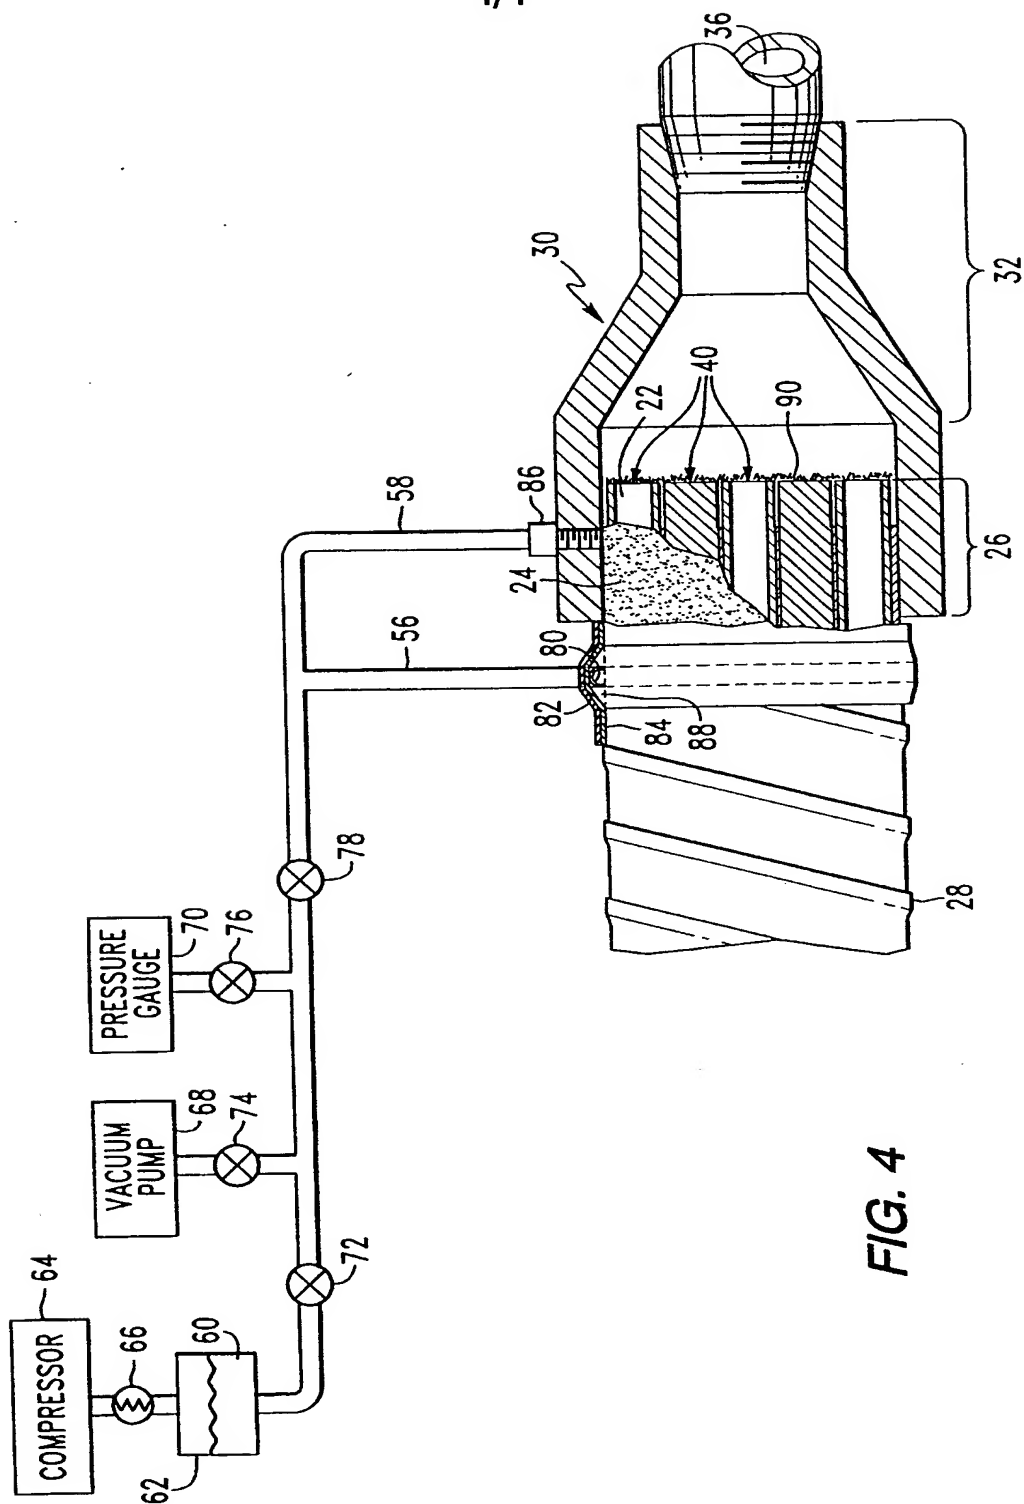
FIG. 4

Figure 4 illustrates the apparatus used to inject resin into voids in the stator coils.

5 Figure 4 illustrates, in partial block diagram form, the apparatus used to perform the method of this invention. A first resin delivery tube 56, and optionally a second resin delivery tube 58, are used to deliver resin 60 to the structure to be impregnated. The resin is contained
10 in a reservoir 62 which is pressurized by a source of pressurized air, such as compressor 64 and regulator 66. A vacuum pump 68 is used to create the vacuum needed for the impregnation, and a pressure gage 70 (preferably a digital gage) is used to monitor the pressure in the tubes and
15 structure. Valves 72, 74, 76 and 78 are used to connect the reservoir, vacuum pump, and pressure gage to the tubes.

To couple the first resin delivery tube to the conductor bundle, the end portion 80 of the tube is cut longitudinally to form a semicircular portion, and that
20 semicircular portion is positioned adjacent to the conductor bundle as shown in Figure 4. A fiberglass tape 82 and resin layer 84 are wrapped over the end portion of the tube 56 to form a vacuum/pressure chamber 88. The second resin delivery tube, if used, can be coupled to the
25 clip using fitting 86. That fitting is typically a pre-existing fitting that would be used for leak testing. The TIG overlay braze 90 forms a seal at the ends of the conductors.

To perform the method of this invention, the apparatus of Figure 4 is connected as shown and valves 74, 76 and 78 are opened. A vacuum is then pulled on the
5 outside of the conductors and held for a predetermined period of time, for example 10 minutes. During this time, the internal openings of the conductors are maintained at atmospheric pressure. If the vacuum has not deteriorated after the predetermined period of time, an operator can be
10 confident that there are no leaks. Then valves 74 and 76 can be closed, and valve 72 can be opened to permit the resin to be injected under pressure into any spaces around the conductors. After the resin is pumped in and cured, the fiberglass tube is sniped off flush and standard
15 insulation materials are applied over the tube end. By injecting the resin into the two areas shown in Figure 4, substantially all voids and leak paths, both existing and those that might form in the future, are sealed. The preferred resin for this process is a low viscosity resin

The number ten brass fitting 86 that is shown in
10 the header (clip) is located in such a way that resin is pumped into the area between the nes Silfos TIG overlay 90 and the original factory braze. The TIG overlay does not penetrate all the way to the original factory braze leaving a chamber composed of interconnecting gaps and capillaries.
15 The resin delivered to this area fills all of these. The other line, the fiberglass tube 56, fills the area behind the clip including any leak paths that may run up the arm of the coil. This chamber consists of the voids in the coil, from original manufacture, which may be part of a
20 water leak path, including that penetrating the original factory braze. The vacuum chamber 88 is formed by wrapping the fiberglass tube 56, which is mitered and bonded directly to two sides of the exposed copper. The fiberglass tube is sanded hemispherical and protrudes out
